Task 1 Deliverable 1.2
*Current Functional Status and Deficiencies Report
for the*

Federal Building 517 Gold Avenue

ALBUQUERQUE, NEW MEXICO

Final Report

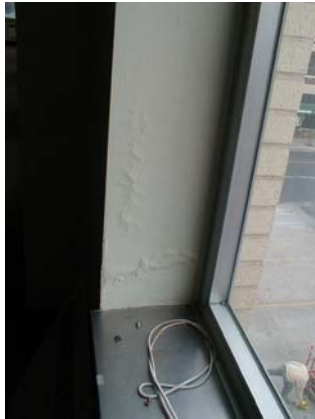
The original pivoting, single glazed, punch windows, are set in anodized aluminum frames. Painted porcelain spandrel panels are provided below the windows. The typical window size is 6'2" high X 3'10" wide. The windows are dated in appearance, and do not provide sufficient vision area for a modern office building. The windows appear to be functional and remain watertight. Several of the porcelain panels have cracked. The painted finish was field applied.

5. The windows are original and are single glazed.

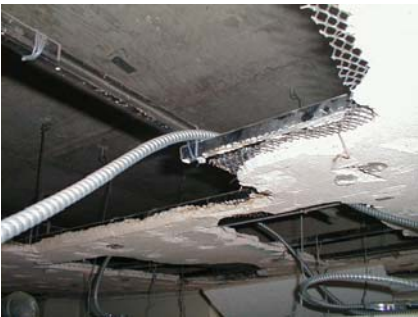
7. View of the original plaster ceiling system, which should be removed.

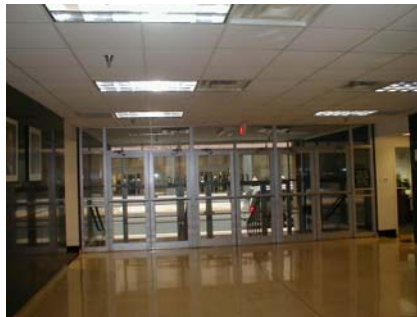
8. View of the main entrance lobby. Note the steps down to grade level.

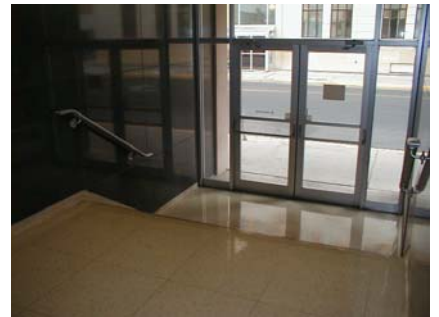
9. View of the steps inside the main fire egress door (typical for both stairways).

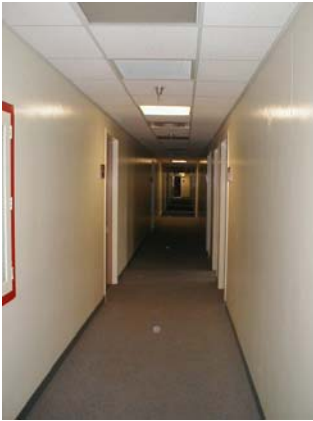
10. View of the typical corridor finishes.

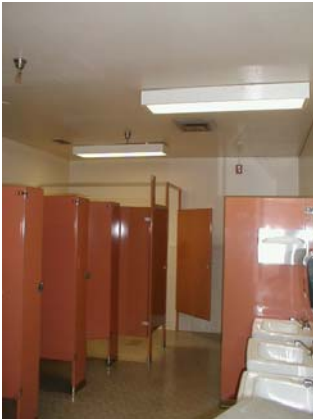
13. View of the typical dated toilet room fixtures and finishes.

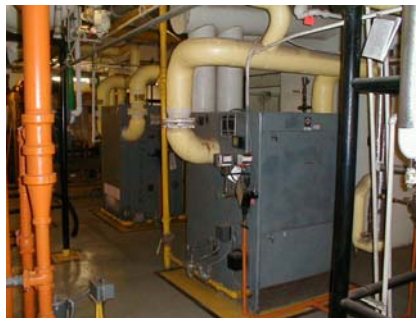
14. The boilers were recently replaced.

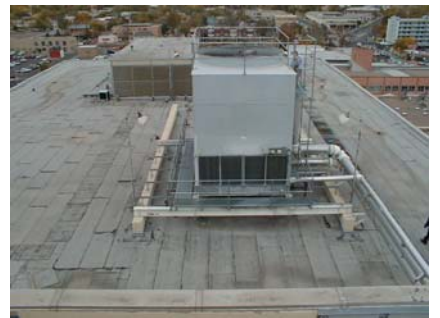
15. View of the cooling tower, which is in good condition.

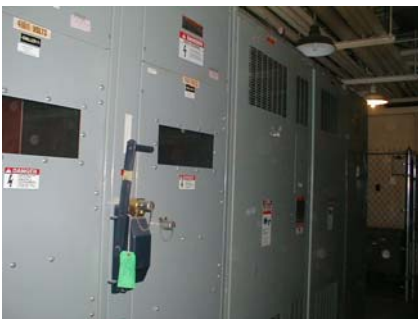
16. The main switchgear is in good condition.

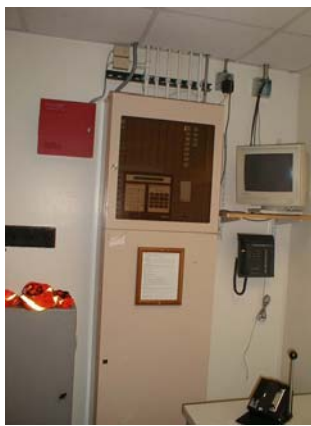
17. The fire alarm control panel will become obsolete, and parts will be difficult to obtain.

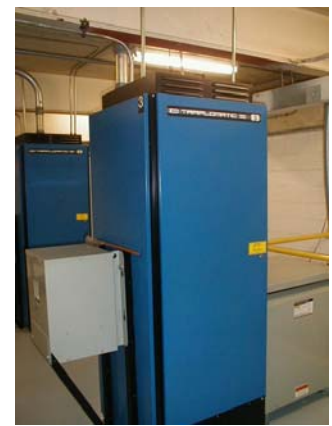
18. The elevator controllers were replaced and are in good condition.
